REPORT NUMBER: FHWA-AZ--8601 1992

HILFIKER REINFORCED SOIL EMBANKMENT WITH FULL- HEIGHT, CAST-IN-PLACE CONCRETE PANELS

Final Report

May 1992

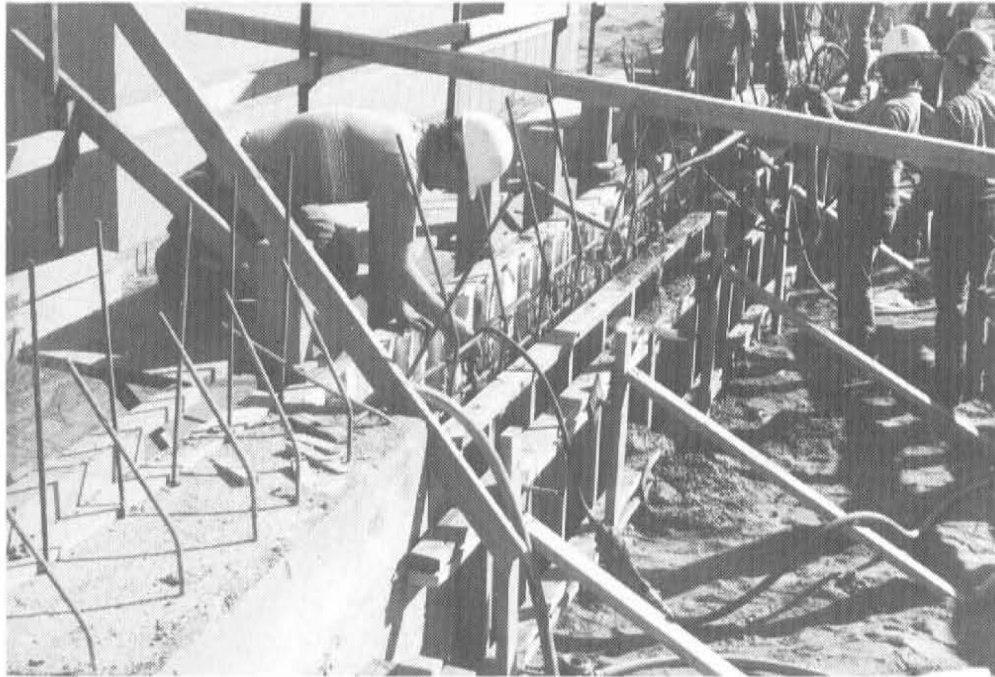
Figure 16 Long Internal Vibrators Initially Used to Vibrate the Concrete Panels.

The concrete was mixed at a batch plant and delivered to the site in transit mixers. The concrete was poured down the full face of the embankment, at times over 20'. Upon pouring, the concrete was vibrated with long internal vibrators as shown in Figure 16. After removing the forms, the concrete showed extensive honeycombing and air voids. Therefore, external vibrators were used in addition to the long internal vibrators. However, because the vibrations of the external vibrators did not transfer well through the rubber and wood forms, honeycombing and air voids were still visible. Use of external vibrators is shown in Figure 17. Figure 18 shows an example of the honeycombing and air pockets in the concrete panels.

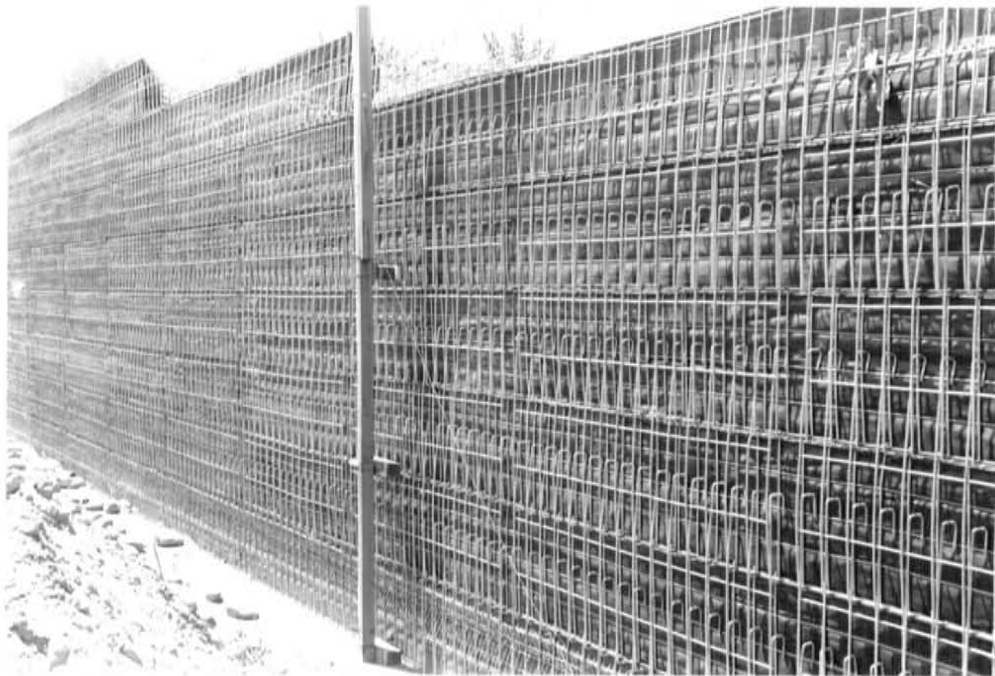
Figure 38 SE Embankment Prior to Placement of the Concrete Forms.

Towards the end of the embankment construction, it became evident that the contractor did not have enough reinforcing mats to raise the embankment to plan elevation. Upon approval from the Hilfiker company, the contractor increased the space between mats to 3' rather than 2.5' as required by the plans. Figure 38 shows the completed embankment prior to placing the concrete forms.

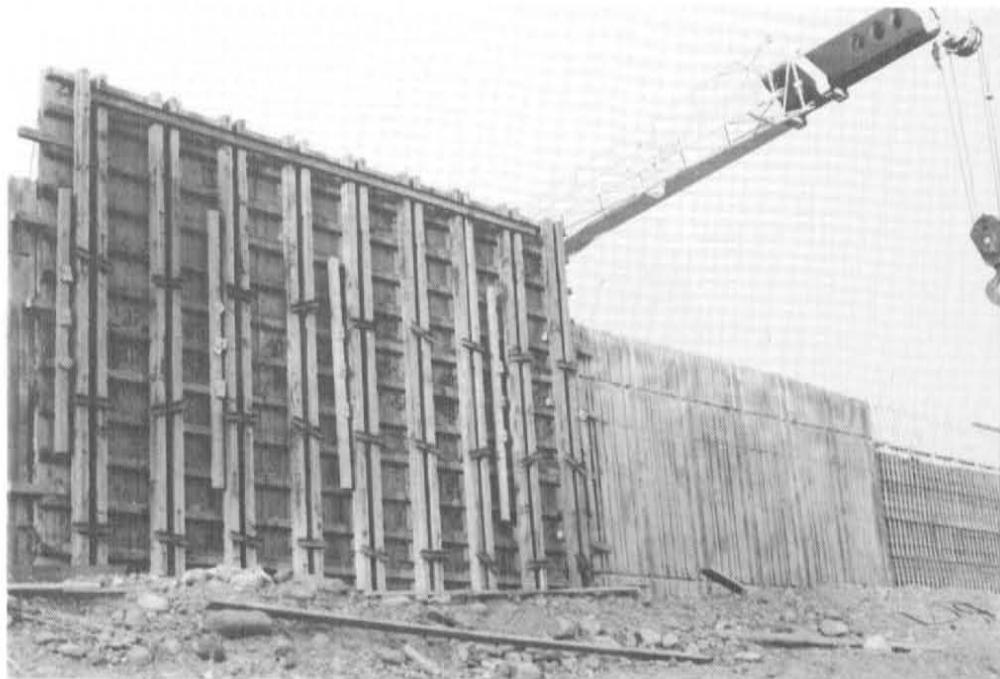
Figure 39 Forms of the SE Wall Were Placed Similarly to the Other Walls.

The concrete for the panels of the face of the wall was poured in similar fashion to the other walls. Figure 39 shows the forms in place. The southeast wall panels, like the others, had no drainage outlets specified in the plans. However, this concrete wall had noticeably fewer shrinkage cracks, and a better quality finish than the other walls. This was probably due to the relative height and length of this wall.

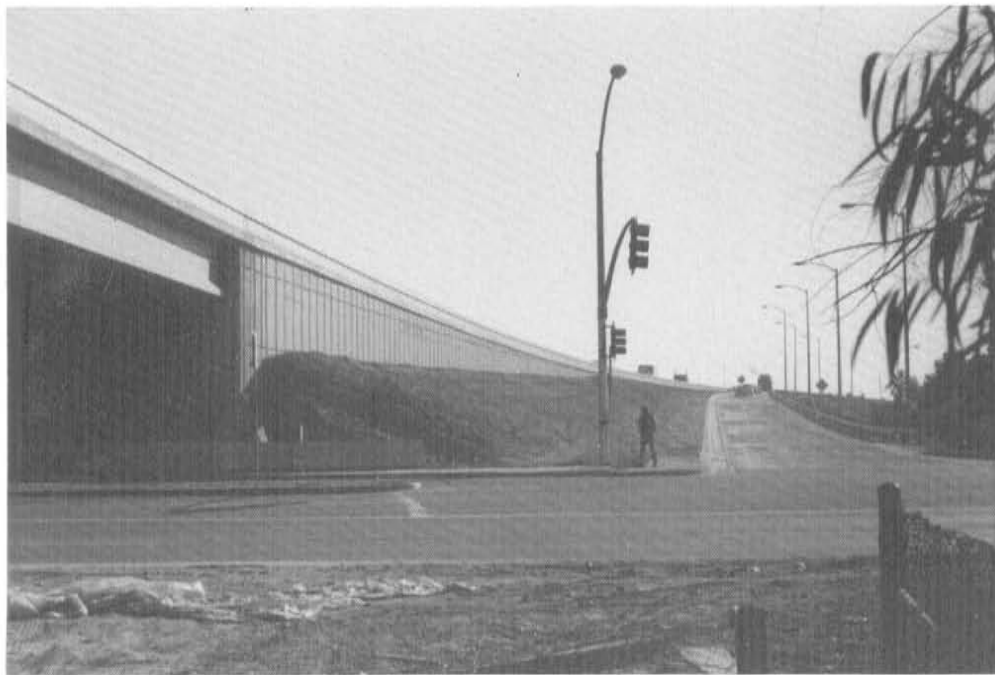
Figure 40 Completed SE Hilfiker Wall (Photograph Facing East).

Upon the completion of construction, 9 aluminum caps were embedded in epoxy along the top of the southeast wall. The caps were surveyed to monitor movements of the wall at future dates. Figure 40 is a photograph of the completed southeast Hilfiker wall.

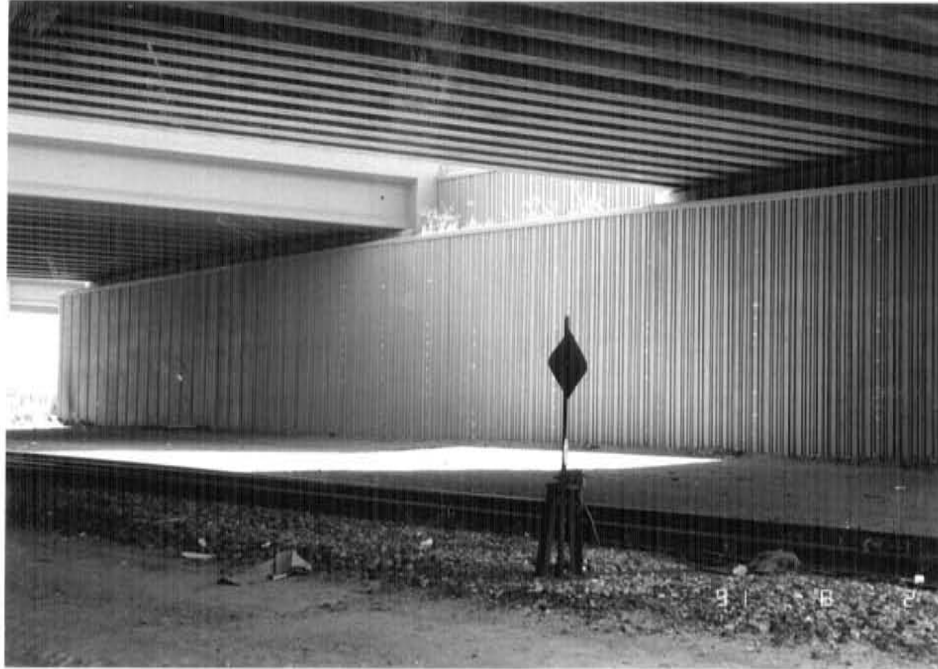
Figure 53 South Retaining Wall at the SPRR Overpass.

Inspection of the VSL walls revealed many horizontal hairline cracks in the walls. The cracks appeared throughout the height of the walls, but were most frequent in the lowest one-third of the walls.
